**Product:**

AquaKat

**User:**Härterei Müller & Hayer  
GmbH & Co. KG**User application report****Consultant:**d. plocher  
katalytic systems e. K.  
Zum Hecht 48  
D-88662 ÜBERLINGEN / NUSSDORF  
Phone: +49 7551 94 78 41  
Email: d.plocher@katalytic-systems.de**Date:**

July 2009 to July 2010

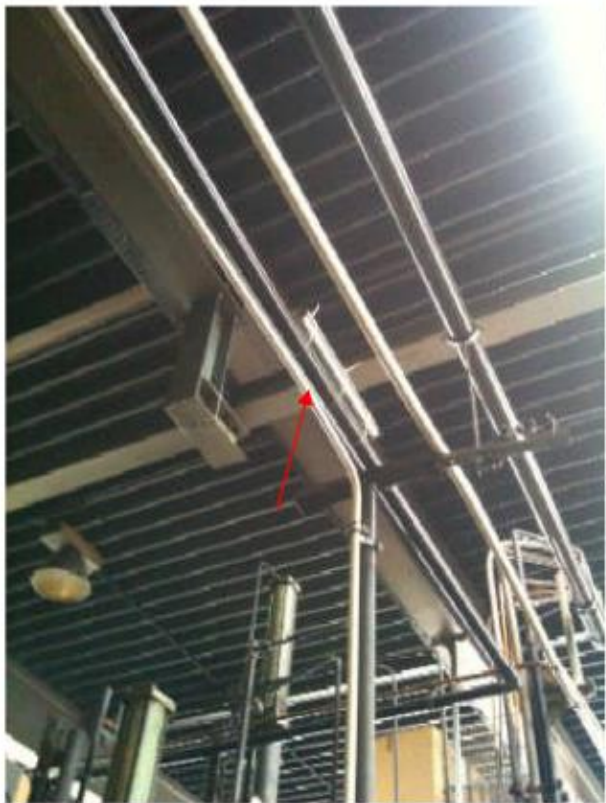
In July of 2009 an AquaKat XXL was installed on the central cooling water manifold and one AquaKat XL each on the most affected furnaces.

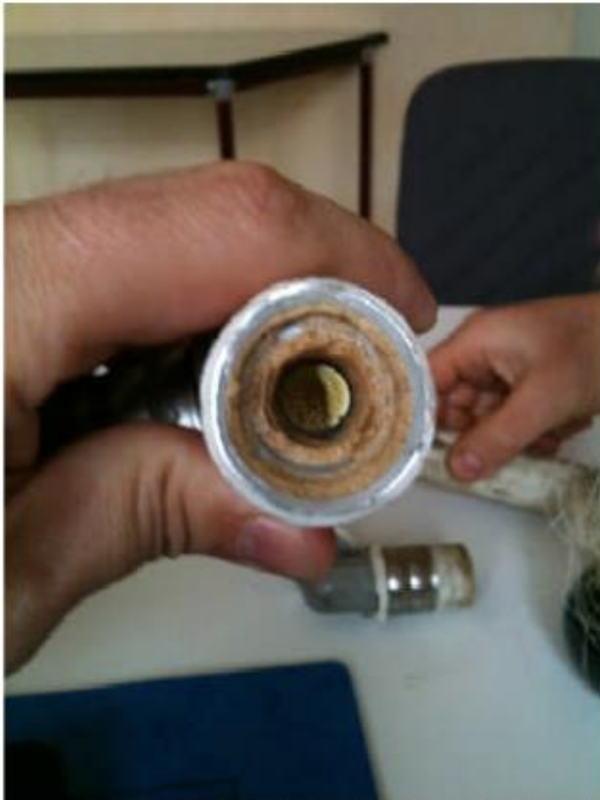
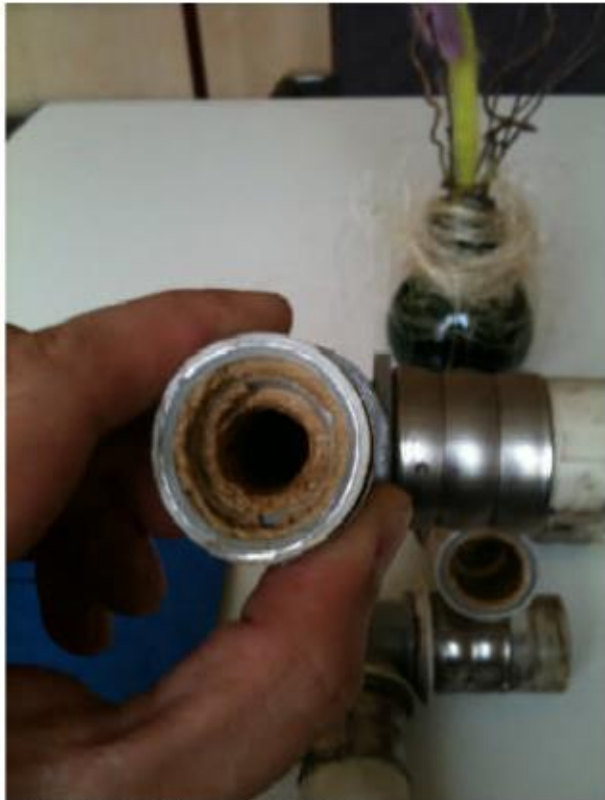
Every three or sometimes even every two months the machines' cooling pipes are so badly affected by limescale that they close up altogether and it is no longer possible to cool the furnaces.

Above: condition of the pipe after approximately 3 months of operation

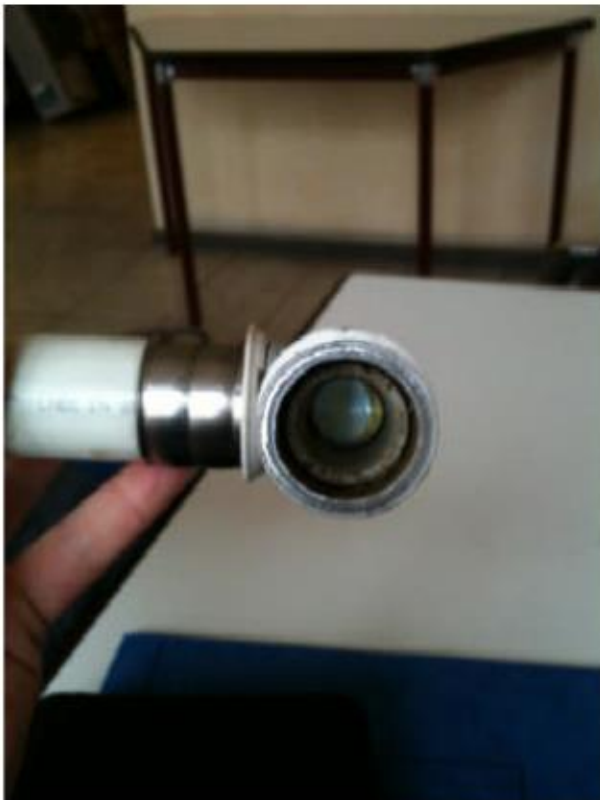
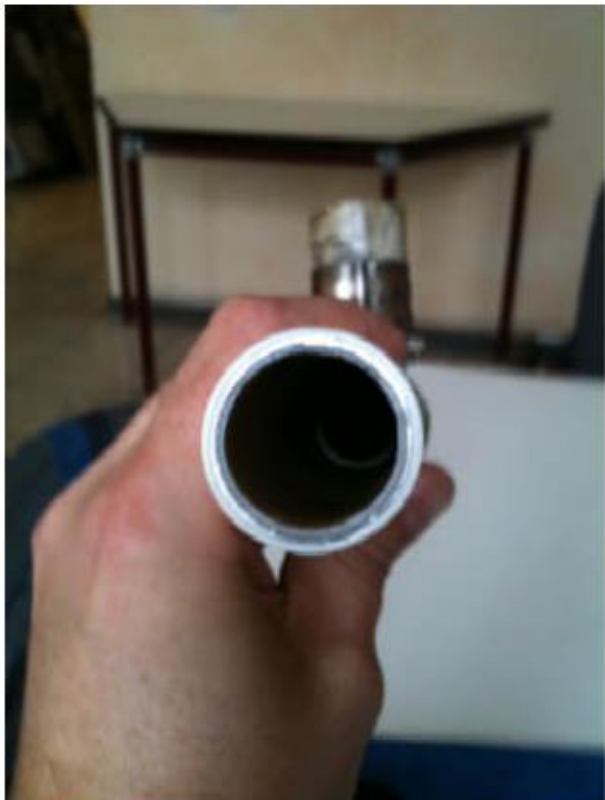
Since the AquaKats were fitted, it has not been necessary to descale the systems once!

Above: condition of the pipe after 3 months of operation with AquaKat! The cooling system has now run perfectly since July 2009 and has not needed to be descaled since.
