**Product:**  
AquaKat

**User:**  
Härterei Müller & Hayer  
GmbH & Co. KG

## User application report

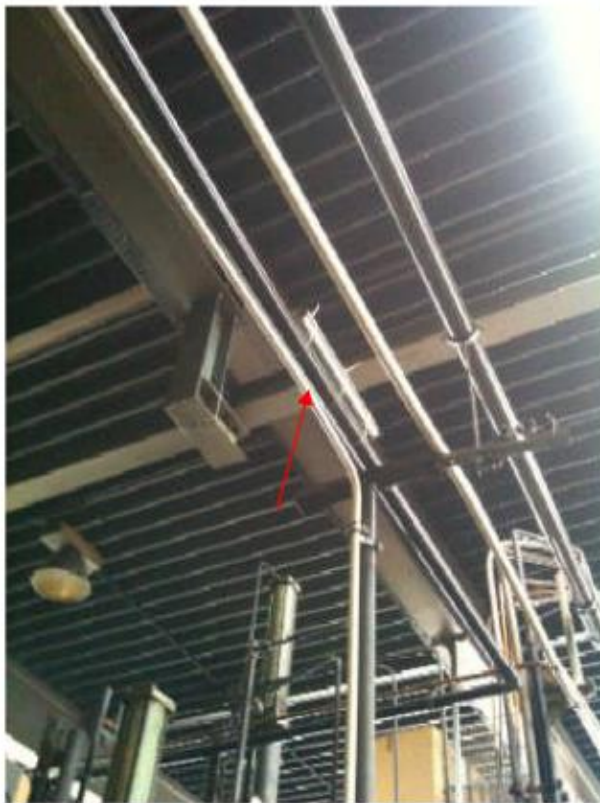
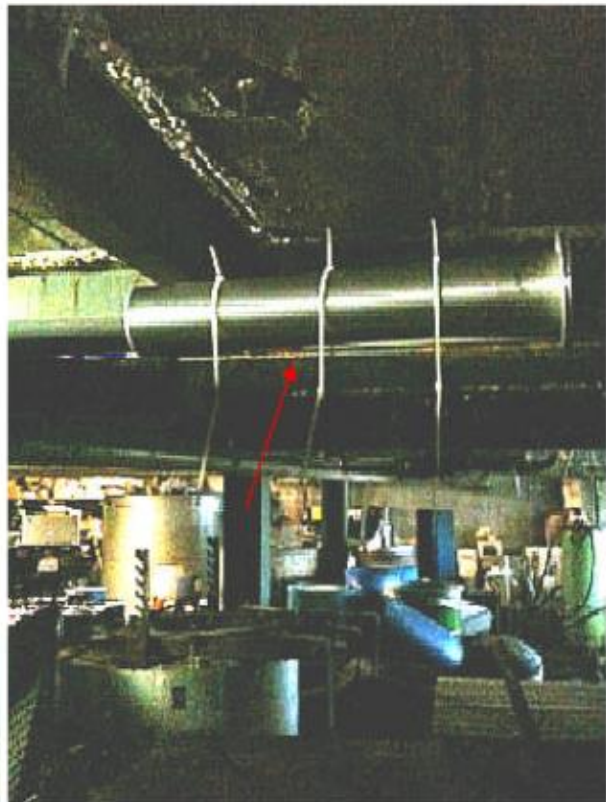
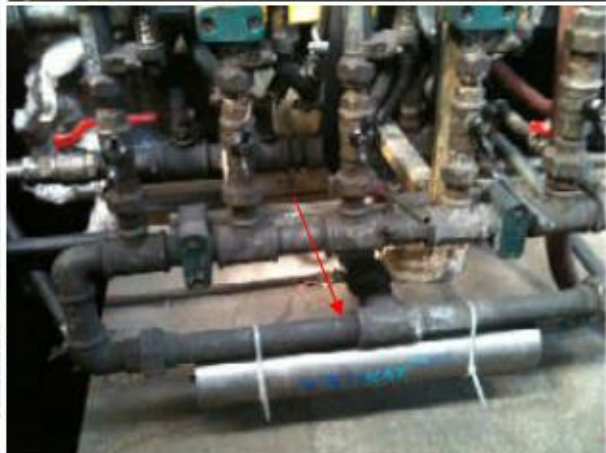
In July of 2009 an AquaKat XXL was installed on the central cooling water manifold and one AquaKat XL each on the most affected furnaces.

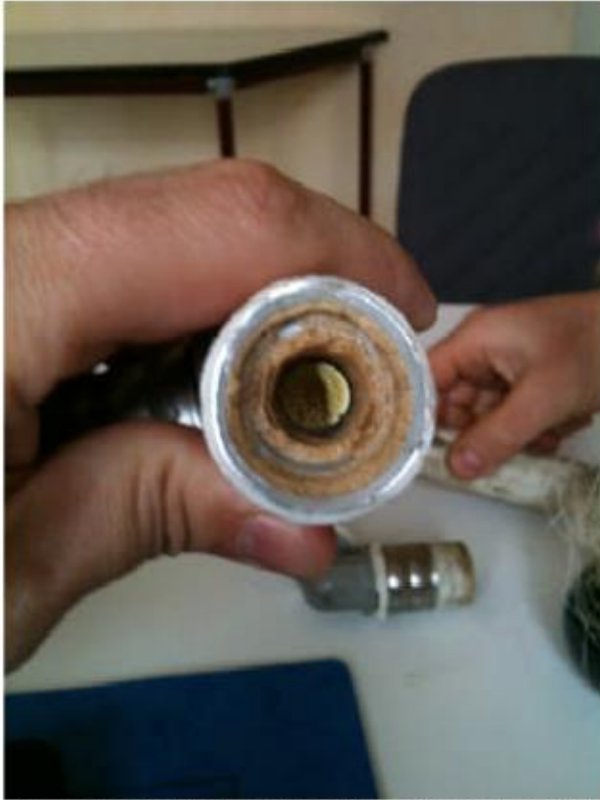
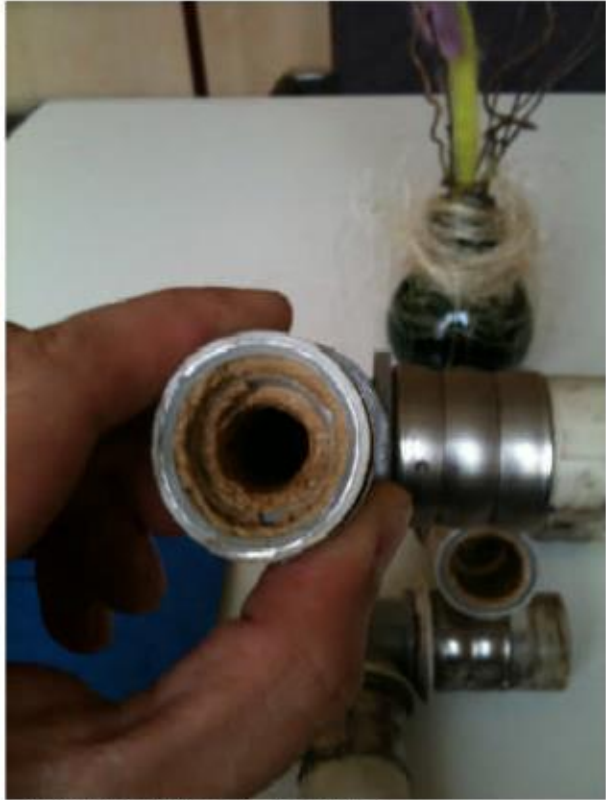
Every three or sometimes even every two months the machines' cooling pipes are so badly affected by limescale that they close up altogether and it is no longer possible to cool the furnaces.

Above: condition of the pipe after approximately 3 months of operation

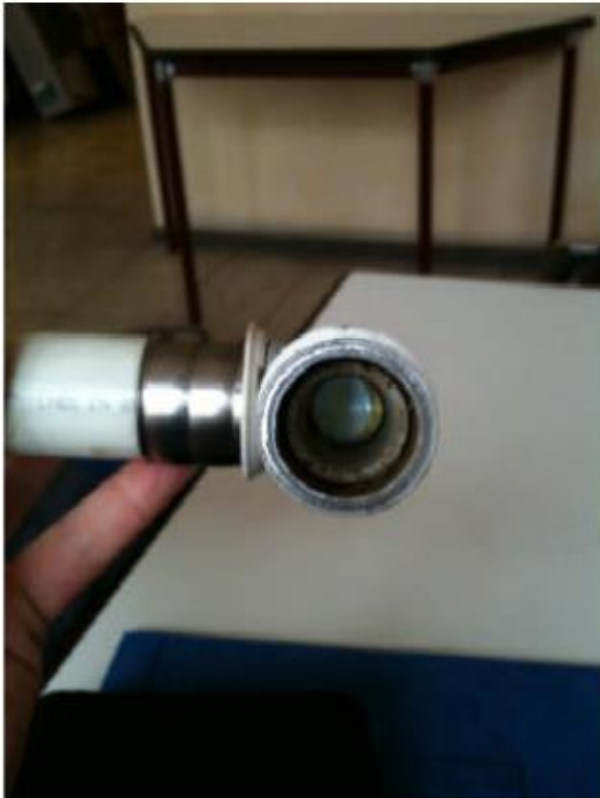
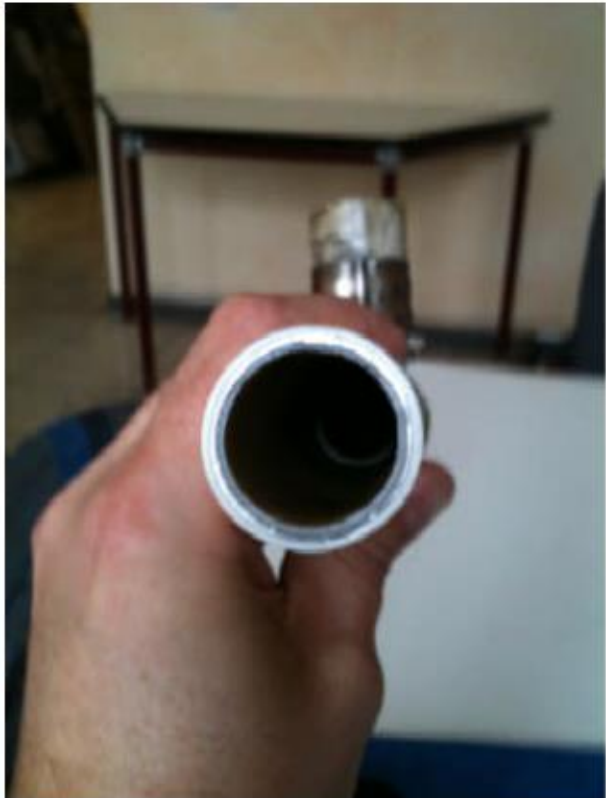
Above: condition of the pipe after 3 months of operation with AquaKat! The cooling system has now run perfectly since July 2009 and has not needed to be descaled since.
